BRAKE SHUDDER – RECOMMENDED SERVICE PROCEDURES FOR DISC MACHINING & INSTALLATION

VT

(GROUP 5)

Update

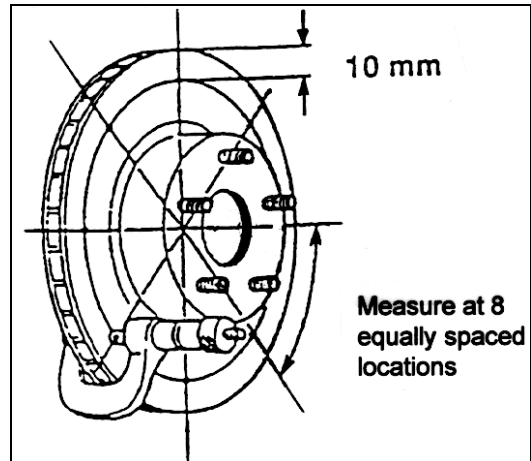
FIGURE 1 Measuring Disc Thickness Variation
[DTV = Maximum thickness – Minimum thickness]

Brake shudder primarily occurs as a result of variation in the thickness of the brake disc. This in turn causes variations in brake surface pressure as the varying thickness disc passes between the pads during braking.

The variation in thickness of the disc can be measured with a micrometer as shown in Fig 1.

NOTE. A disc that varies in thickness by more than .015mm (15 micron) will cause brake shudder.

New discs develop Disc Thickness Variation (DTV) as a result of excessive lateral runout in the disc combined with caliper drag during non-braking running time. On each revolution of the disc a portion of the disc comes into contact with the pad. Eventually the disc wears at the point of contact thus creating thickness variation.

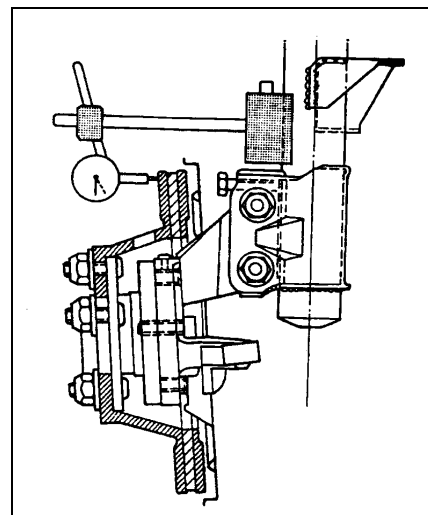
FIGURE 2. Measuring disc lateral runout

The term “lateral” literally means “sideways”. Assembled lateral runout is measured with a dial indicator whilst rotating the disc on the vehicle.

Apart from accident damage, excessive assembled lateral runout of discs may result from one or more of the following:

A front hub/bearing unit may show a runout of 0.030 mm near the outer edge of the mounting face. The brake disc itself may have lateral runout of 0.030 mm near its outer diameter. These runouts taken separately are within allowable tolerances. However, if the disc is placed on the hub so that the high point on the disc is aligned with the high point on the hub then the combined result is an excessive lateral runout (at the disc outer diameter) of about 0.090 mm.

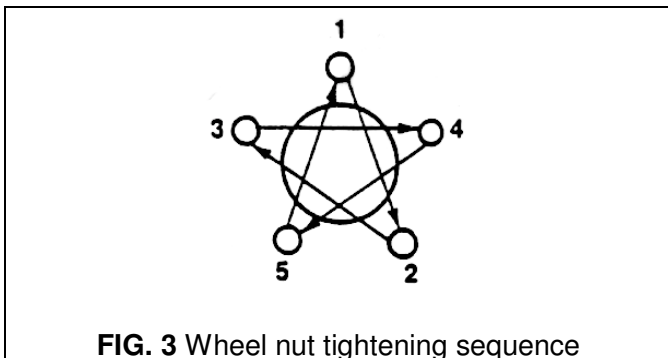
FIG. 3 Wheel nut tightening sequence

Over-tightened wheel nuts or those tightened in the wrong sequence will cause distortion of the disc and result in excessive lateral runout.

Failure to observe this may result in warped discs which lead to development of brake shudder.

To prevent distortion of the disc and hub assembly, wheel nuts must be tightened to the specified torque in two steps, using a suitable torque wrench. Follow the nut tightening sequence as shown in Figure 3.

DO NOT USE AN AIR IMPACT GUN TO TIGHTEN WHEEL NUTS UNLESS IT IS FITTED WITH A TORQUE LIMITER BAR.
